# CROSS

## Confidential Reporting on Structural Safety

### NEWSLETTER No 28, OCTOBER 2012

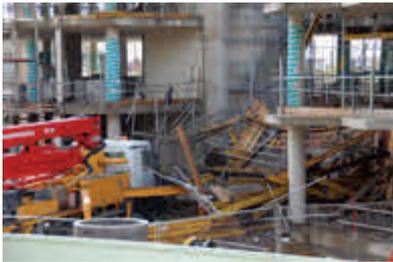
The construction site for a new university building following a scaffolding collapse. Two companies have been fined a total of £100,000 over the incident which occurred when concrete was being pumped onto the third floor of the building and the supporting scaffolding holding shuttering collapsed. The workers' injuries included cement burns to their skin and eyes, and bone fractures. The Health and Safety Executive (HSE) investigation found both the principal contractor for the project and the concrete subcontractor allowed the supporting scaffolding to be erected from a preliminary design, clearly marked 'for pricing purposes only'. The drawing did not include all the information needed to erect the scaffolding correctly or safely. The companies also failed to ensure the scaffolding was checked before allowing the concrete to be poured.

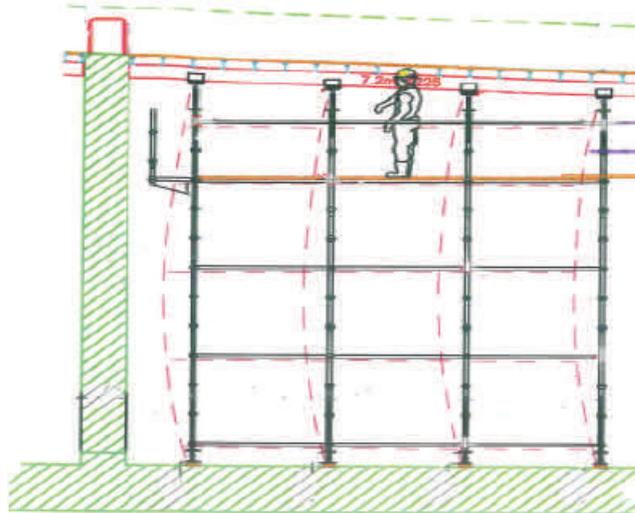
An inspection revealed numerous deviations from the scaffold arrangement shown on the certified design drawings, primarily that transverse diagonal

bracing was fitted to every 4th bay and not to every bay. Collapse was prevented by bowing distortion of the standards caused the proprietary ledgers to become wedged and thus provided some moment capacity at each joint between the standards and the ledgers. Furthermore the decking was locked between RC walls, thus preventing sway at the top of the falsework. It is likely that further distortion would have resulted in local collapse, as the diaphragm effect of the decking would be unlikely to extend to seven bays. Local collapse of the structure could have precipitated a more comprehensive progressive collapse.

- Vetting of sub-contractors
- Adequacy of Management Procedures
- Training on Management Procedures
- Training and recognition of Temporary Works Co-ordinator role

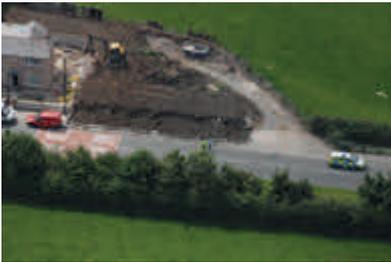
The director of a building firm has been jailed for two years after a substandard wall collapsed killing a three-year-old girl. He was found guilty of gross negligence manslaughter. An investigation by police and the Health and Safety Executive found that the wall had been acting as a retaining wall but had not been

*Aerial view of the scene of the wall collapse*

designed or constructed for this purpose and fell under the weight of the earth stacked up against it as the child walked past.
