# CROSS

## Confidential Reporting on Structural Safety

### Newsletter No 6, April 2007

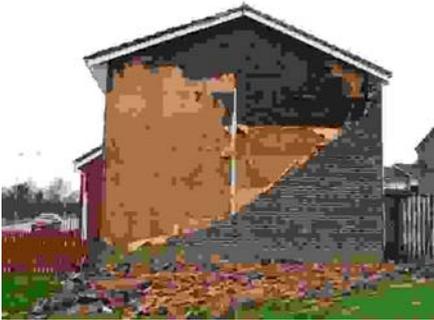
Following request for examples of wind damage this collapse was reported of the external brick skin of gable wall of a two storey timber frame terraced house.

*Comment It appears that the ties have either failed or pulled away from the timber frame behind. During recent periods of strong winds there were many press reports of damage to domestic dwellings constructed in more traditional ways. See News Items. (Report 078)*
