# CROSS

## Confidential Reporting on Structural Safety

### Newsletter No 24, October 2011

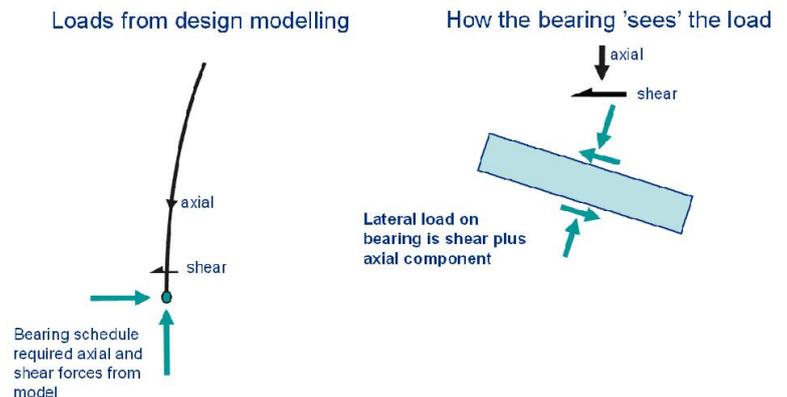
The drawings being prepared for the arch springing area were given a lot of attention but this was focused on the aesthetic and construction aspects. However, although the designer correctly extracted forces from the model, it is believed that he gave insufficient attention to the drawings being prepared and how they communicated his design. Consequently he did not realise that the bearings were shown to be aligned parallel to the plan skew of the bridge and not perpendicular to the line of thrust from the arch legs as was his design intent. The error was compounded by the checker who suffered a similar lack of appreciation of what was shown on the drawings and agreed the design to be correct. See the diagram below.

Whilst dealing with construction issues related to the casting of the arch legs a senior engineer noted the anomaly between what was shown on the drawings and the figures in the bearing schedule and, after investigating the design calculations, concluded that the actual lateral load on the bearing would have been some four times greater than required by the schedule. Although the bridge legs had not been erected they had been cast. The construction error, which involved incorrect reinforcement layout, had already necessitated the decision to recast the legs. It was at this stage that it is reported that the design error was detected. It also provided the time window to revise the leg end geometry to eliminate the undesirable component of lateral reaction and restore the original design intent. It was however necessary to undertake some challenging re-modeling of the bridge foundations that were already cast. The discovery of the design error

was fortuitous. If there had been no issues with the precasting of the concrete legs, the additional load on the bridge support would probably have remained undiscovered until the temporary works for the insitu deck were released. Under these circumstances the bearings would have experienced significantly larger lateral loads than they were designed for. This may have led to the safety or the performance of the bridge being compromised. It is however more likely that the overloading would have manifested itself before the falsework was fully released giving an opportunity to reinstate temporary support and thus address the issue. This would, however, have left the considerable problem of restoring the bridge to a safe condition. Overall, the errors resulted in significant costs and delay to the works on site. However, the bridge was duly safely constructed and is now complete and in service.

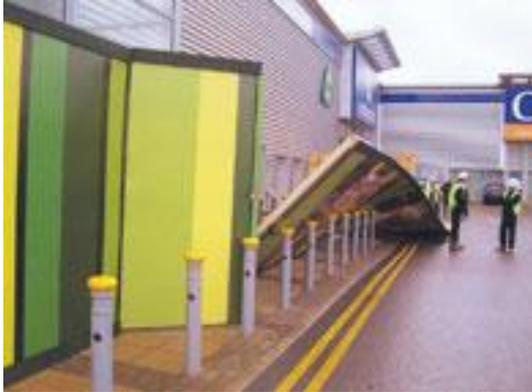
A two-year-old child escaped with minor injuries injury after a 2.4 m high, 17m wide, shop hoarding collapsed on him as it was blown over.

The main contractor and the hoarding sub-contractor pleaded guilty to breaching the Construction (Design and Management) regulations 2007 by failing to ensure that the hoarding was properly designed and built and were fined £4,000 with costs of £5,273, and £4,000 and with costs of £6,963 respectively. No formal design was carried out; therefore no consideration had been given to wind loads or stability. To compound the issue, changes were made to the agreed (albeit un-designed) arrangement when the hoarding was constructed on site. There was no recognition that this was temporary works and so the principles set down in BS5975 were not followed.

Hoardings can be significant structures in their own right, subject to large wind forces and deserve appropriate attention. Inadequately designed free standing walls collapse with sometimes fatal results and the same can happen with hoardings. There is general concern in the industry not just at the risk of collapse, but also at the time wasted in bespoke designs for what is a standard item in many respects. Apparently simple structures are frequently built and perform successfully using rules of thumb based on experience. It is often the case that failure to comply with CDM Regulations result in prosecution when matters on site go wrong. BS 5975 relies heavily on tasks and duties being performed by a "competent person" for whom it gives a long definition. The Temporary Works Forum (TWF) is considering the matter.

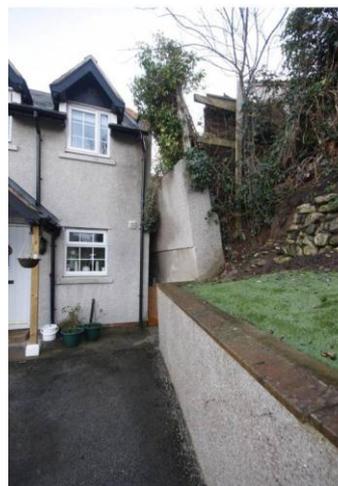
A developer built a small estate adjacent to an existing property (shown on the left of the photograph) with a retaining wall between the two. The reporter checked the proposal on behalf of the owner and told the developer that it was not safe and would be dangerous. The builder took no notice so the reporter called the local council who refused to get involved and the wall was built. It was constructed of concrete blocks, was almost two storeys high, and had no reinforcement. Melting snow seems to have been too much for the wall which collapsed moments after someone from the adjoining property had

walked past. The wall fell onto the adjacent property and cracked the end walls, and there is the possibility of further collapse as the surrounding ground is now unstable.

*A major concern hereto has been that Building Control has no duty to look at such structures, yet from the many reports sent to CROSS retaining wall failures are common and some are deadly. Examples are seen of completely unsuitable designs and this is one of them. There have been attempts to change the situation but so far without success. All retaining walls can be dangerous and perhaps should be designed by a competent structural engineer unless the walls follow the empirical proportions and conditions illustrated in Approved Document A of the Building Regulations. A call to the HSE might help as this does fall within their remit, but any action may be resource constrained. In the longer term education is part of the answer, but as commercial gains from building irresponsibly may be substantial, these examples are likely to continue. This trait of builders, or anyone else, ignoring professional advice is worrying as it appears to be becoming much more widespread. Retaining walls clearly remain a significant issue that requires vigilance.*
